#### BEAVER BROOK DAM CT 00085

HOUSATONIC RIVER BASIN MILFORD, CONNECTICUT

PHASE I INSPECTION REPORT NATIONAL DAM INSPECTION PROGRAM

BEAVER BROOK DAM
BEAVER BROOK
MILFORD, CONNECTICUT
CT 00085
6 APRIL 1981

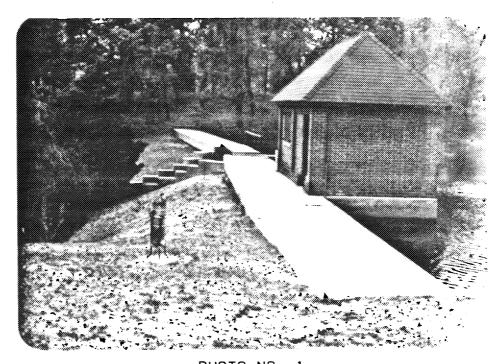
PHOTO NO. 1

DAM AND GATEHOUSE FROM LEFT ABUTMENT.

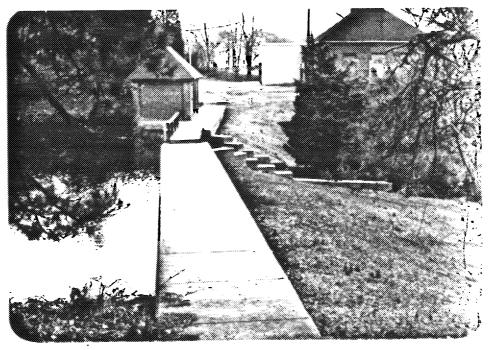
PHOTO NO. 2

DAM FROM RIGHT ABUTMENT.

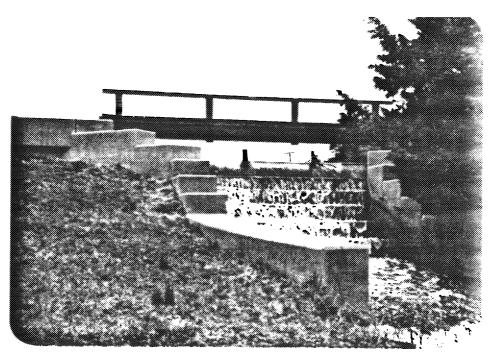
PHOTO NO. 3

SPILLWAY FROM DOWNSTREAM. NOTE FOOTBRIDGE AND BRACKETS FOR FLASHBOARDS.

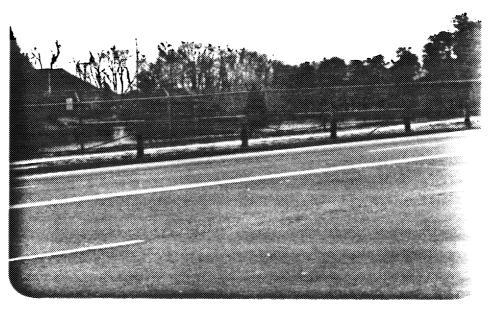
PHOTO NO. 4

The dam has a watershed of 1.7 square miles and a storage capacity of 95 Acre-Feet at the top of the dam. Approximately 300 feet upstream of the dam U.S. Route 1 crosses the reservoir. The highway is about 80 feet wide and has a single 3' x 6' box culvert. The capacity of the culvert was calculated to be about 250 cfs.

DAM LOOKING DOWNSTREAM FROM U.S. ROUTE 1.

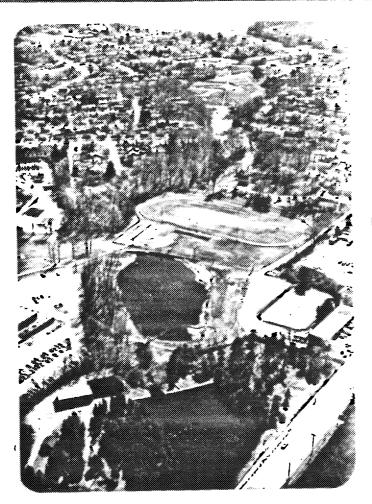
PHOTO NO. 5 \*

Route 1 is about 11 Acre-Feet. Failure of the dam would release only this lower portion of the impoundment as the highway embankment is unlikely to fail.

An inspection and field surveys of the downstream channel indicate that the dam should be classified as "Low" hazard potential. There is ample storage capacity in the downstream reach to dissipate the flood wave from a failure of Beaver Brook Dam.

DAM, IMPOUNDMENT AND DOWNSTREAM AREA. NOTE WIDTH OF HIGHWAY, SMALL IMPOUNDMENT BETWEEN HIGHWAY AND DAM, SMALL DOWN-STREAM RECREATIONAL POND, AND UNDEVELOPED FLOOD PLAIN.

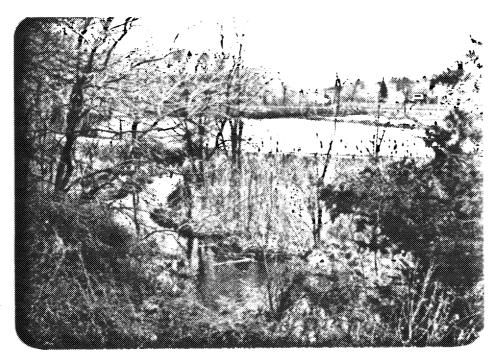
PHOTO NO. 6

CLOSE-UP OF AREA IMMEDIATELY BELOW DAM.
